Manhole Inspection Summary

Manhole # S39I__007MH

Location Address: **711 East Pratt**

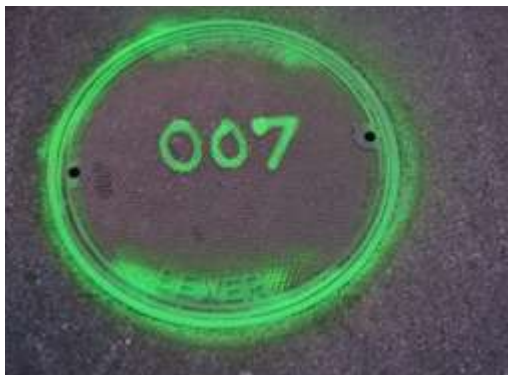
Miscellaneous

mh cover

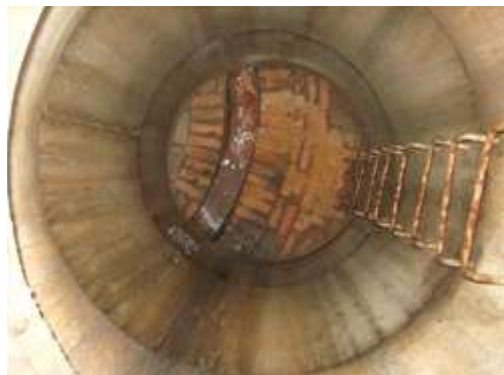
Defect 1

Infiltration: ☐ None ☒ Joint ☐ Cracks ☐ Mortar ☐ Roots ☐ Wall

Steps Count: **10** Missing: **0** ☒ Corroded

corbel infiltration staining, corroded steps

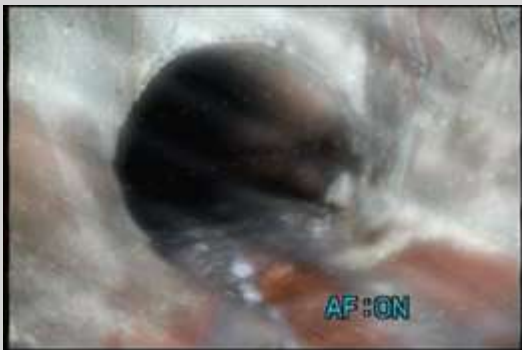
12 O'Clock Outflow

8 in. Circular Gravity Sewer
Pipe Out @ 12 O'Clock

Pipe Height: **8.4** (in.) Rod and Bar (Angled)
Pipe Material: **Clay** ☐ Pipe Lined
Invert Depth: **12.16** (ft.) Flow Characteristics: **Fast**
Deposits: ☒ None ☐ Mud ☐ Sludge ☐ Debris ☐ Grease
Silt Depth: **0** (in.) Deposits Extent:
Infiltration: **None** Pipe Seal Cond: **Sound**

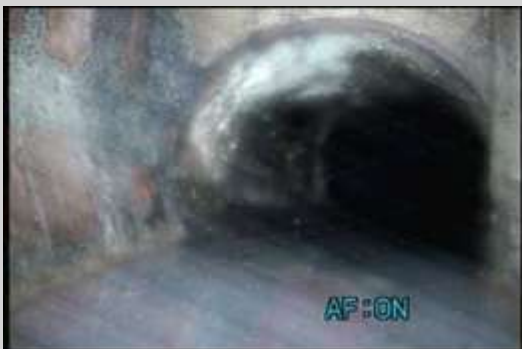
7 O'Clock Inflow

8 in. Circular Gravity Sewer
Pipe In @ 7 O'Clock

Pipe Height: **8.4** (in.) Rod and Bar (Angled)
Pipe Material: **Clay** ☐ Pipe Lined
Invert Depth: **12.02** (ft.) Flow Characteristics: **Fast**
Deposits: ☒ None ☐ Mud ☐ Sludge ☐ Debris ☐ Grease
Silt Depth: **0** (in.) Deposits Extent:
Infiltration: **None** Pipe Seal Cond: **Sound**
